**NSWCCD-65-TR-2001/23**

October 2001

## **Structural Integrity and Damage Evaluation Routine (SIDER) for Quality Control and Health Monitoring of Structures**

Subj: COLLABORATIVE STRUCTURAL EVALUATION OF A HIGHWAY COMPOSITE  
DECK BRIDGE

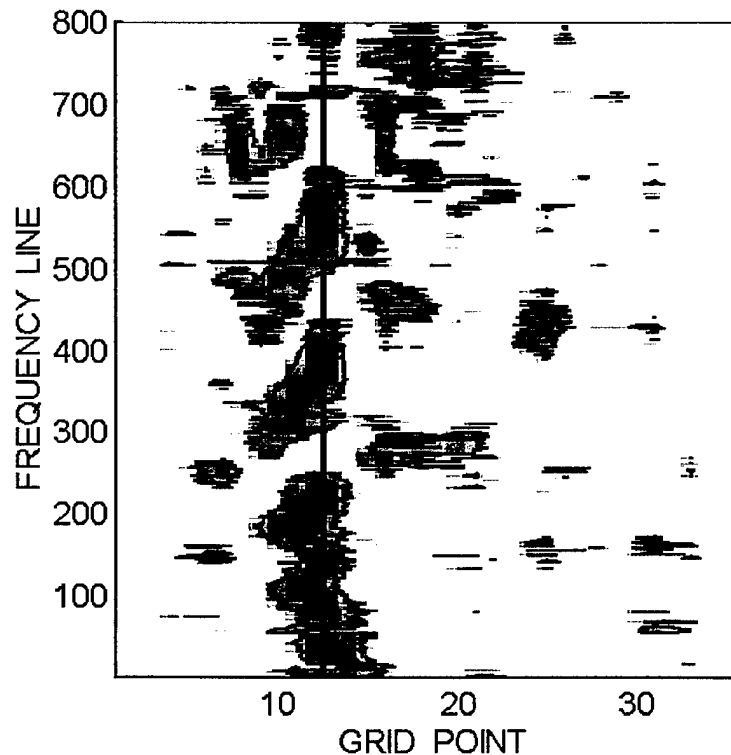
The procedure is repeated separately for every frequency and for every test point on the structure. For a one-dimensional structure (beam), the resulting output can be shown as a contour plot of frequency versus position. Figure 1 shows the results of an experimental BGSM for a 0.914 m long  $\times$  76.2 mm wide  $\times$  6.33 mm thick steel beam with simulated damage created by milling a 0.13-mm deep groove across its width. The resulting damage index plot has a feature which shows consistently at nearly all frequencies at the location of damage (grid point 12.5). It should be noted that one advantage of using the BGSM is that it does not require a footprint of information about a presumably undamaged structure (either finite element or experimental). This means that the BGSM is suited to the inspection of structures that have been in service for some period without a prior inspection.

**Figure 1. Experimental Broadband Damage Index for a 6.33-mm Thick Steel Beam with a 2.8-mm wide, 0.13-mm Deep Groove at the Position Marked**

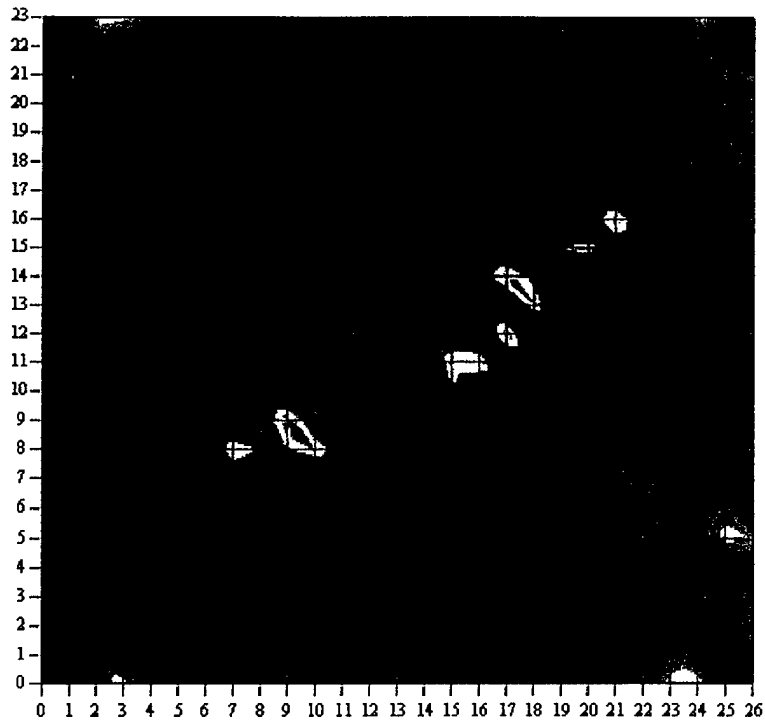
Figure 2 shows the reduced summary plot for one of the foam core panels that was impacted at its center with a 4-inch diameter spherical tup at an energy level of 1344 ft-lbs. The SIDER procedure indicates that, in addition to the damage at the impact site, there is other damage approximately along the diagonals of the panel. After this vibration examination was complete the panel was end-loaded to destruction. The panel failed along the lines identified by the SIDER analysis.

**Figure 2. SIDER Summary Plot for Foam Panel after Impact at 1344 ft-lbs**

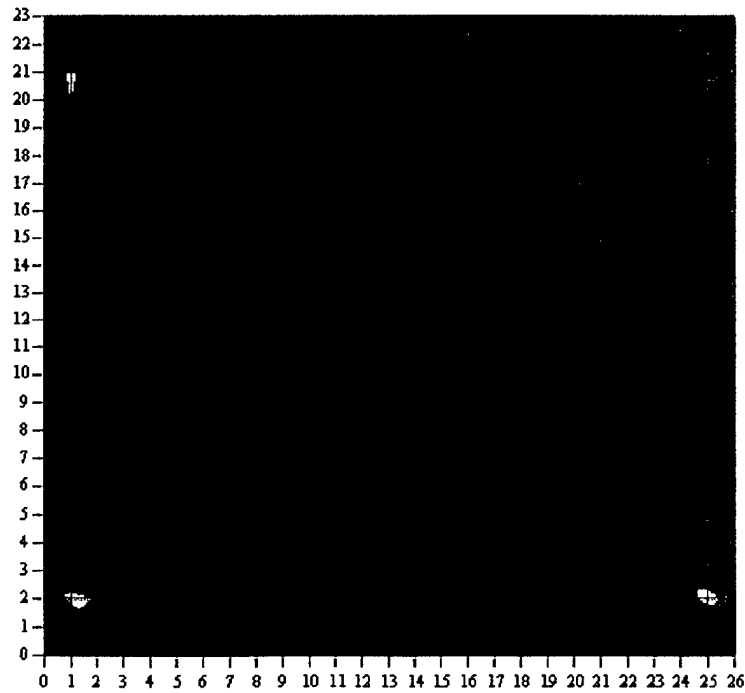
In comparison, Figure 3 shows the SIDER summary plot for a panel that had not been impacted. The plot does not show any features of significance, suggesting uniformity and a lack of damage.

**Figure 3. SIDER Summary Plot for Foam Panel that was not Impacted**

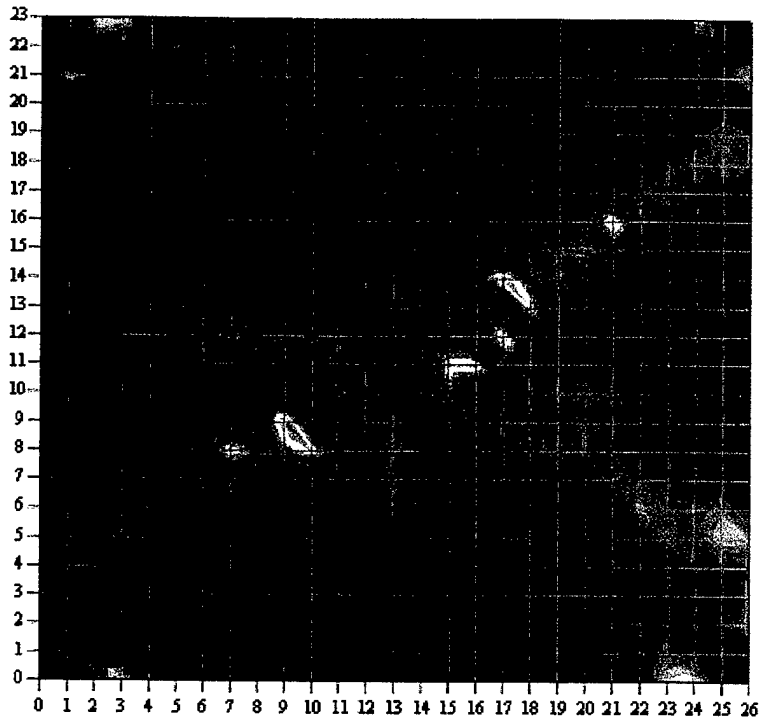
Figures 4 and 5 show the same information as Figures 2 and 3, but after statistical enhancement. The damage on the impacted panel is much easier to interpret, and the plot for the undamaged panel is much ‘cleaner’.

**Figure 4. Enhanced Plot for Damaged Foam Panel**

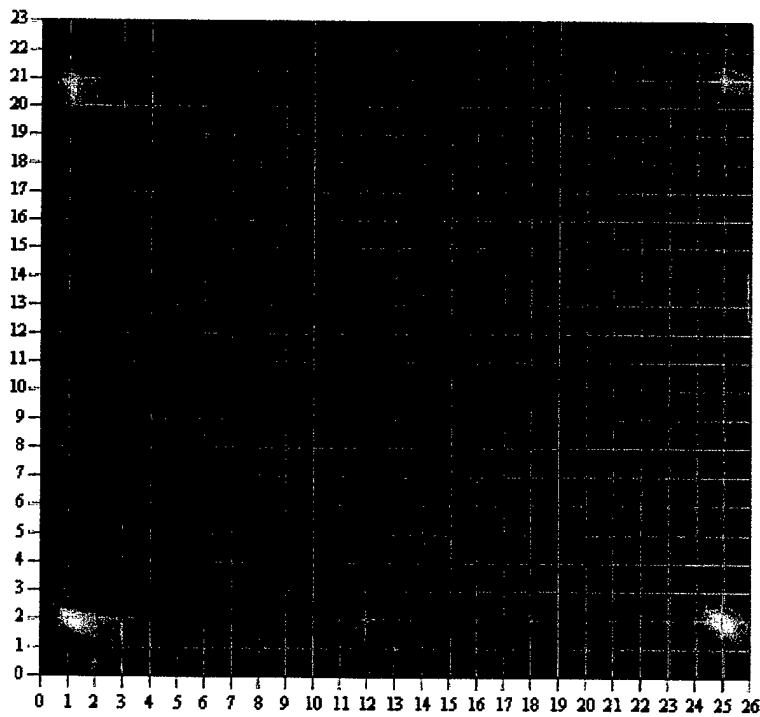
**Figure 5. Enhanced Plot for Undamaged Foam Panel**

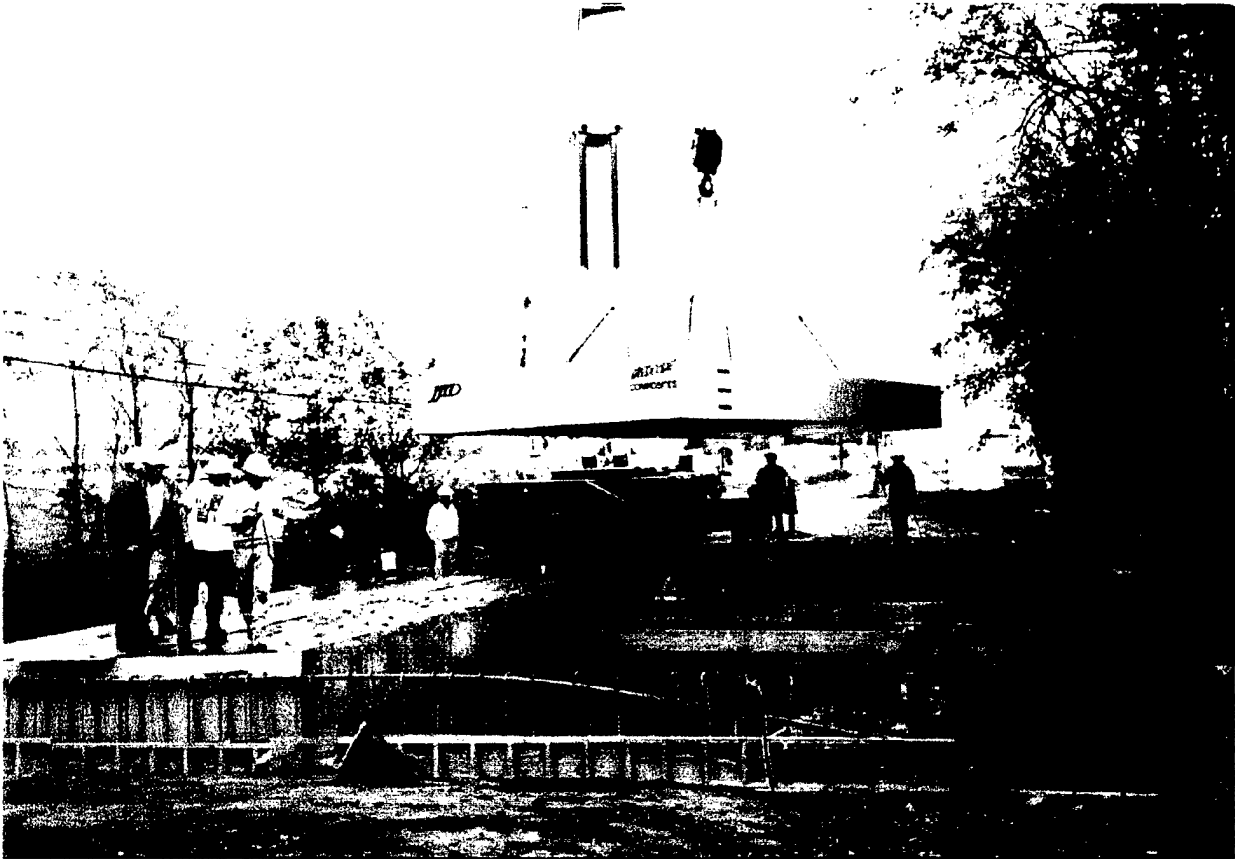
Delaware Bridge 1-351 is located on Business Route 896 in Glasgow, Delaware. Figure 6 shows the bridge during installation, shortly before it was opened to traffic in November 1998. The bridge consists of two E-Glass/vinyl ester sections each 3.9 m (13-ft)  $\times$  10 m (33 ft) joined in the traffic direction. The section is a sandwich construction consisting of a 0.7 m (28-inch) deep core and 0.013 m (0.5-inch) thick face sheets covered with approximately 0.038 m (1.5-inch) of latex modified concrete. During installation, the two sections were bonded together and were held in alignment with a composite splice plate, which is now covered with the concrete wear surface.

**Figure 6. Installation of the All-FRP Bridge in Delaware**
